MERRIMACK RIVER BASIN
LEOMINSTER, MASSACHUSETTS

FALL BROOK RESERVOIR DAM
MA 00869

**PHASE I INSPECTION REPORT
NATIONAL DAM INSPECTION PROGRAM**

SEPTEMBER 1979

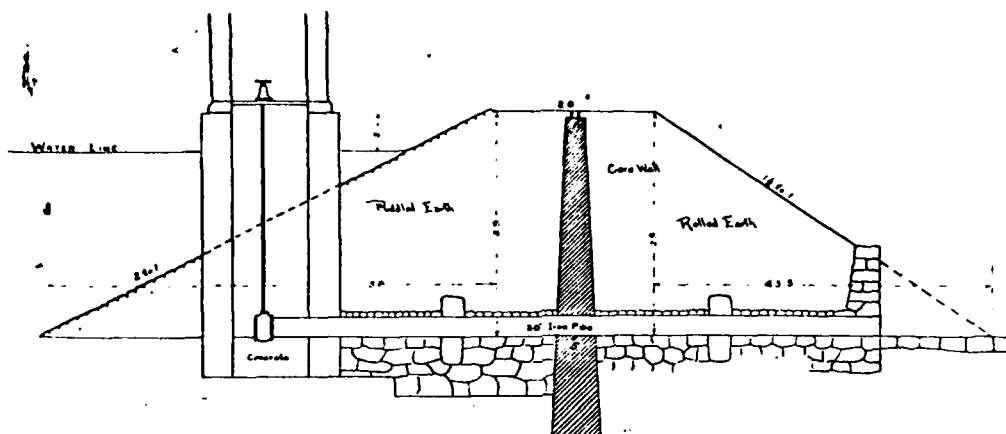
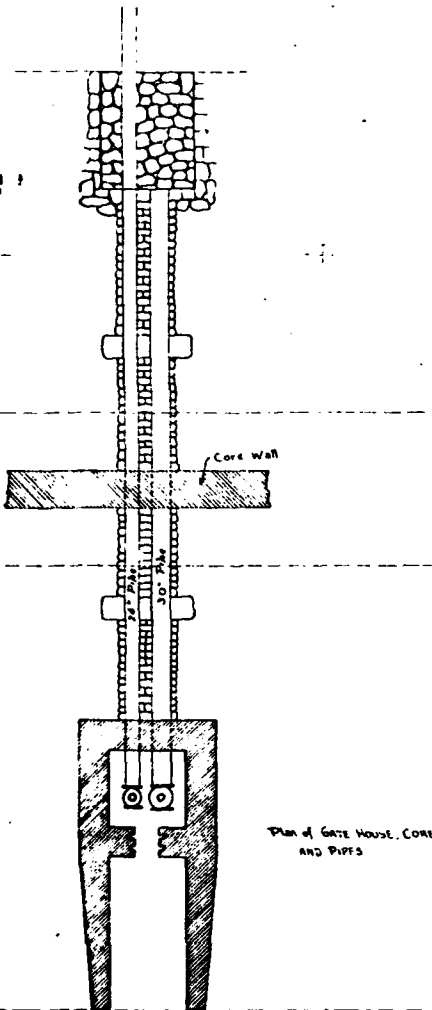
SECTION OF DAM SHOWING
GATE-HOUSE

Discrepancies in the design drawing (Figure B-4) were noted during the Phase I survey and inspection. Figure B-4 shows that the invert of the 30-inch pipe was about 29 feet below the crest of the dam, which would be approximately at El 628. However, the field survey measured the downstream invert of the pipe at El 619.7. The drawing also shows the 24-inch water supply main continuing parallel to the 30-inch pipe up to the headwall at the outlet, rather than changing direction toward the manhole.

- b. Design and Construction Data. The dam and dike were constructed in 1896. A drawing (Figure B-6) dated 1895 and signed by Charles A. Allen, Engineer, shows the core wall in plan and profile for both embankments. The top of the core wall at the main dam is 2.5 feet thick and at approximately El 656, which is about 4 feet above the crest of the spillway. According to the drawing, the total height of the core wall is about 41 feet, and the thickness increases to 6.5 at the bottom. The foundation material for the core wall is unknown.

Figure B-6 also shows that the outlet pipe is encased in stone, on a stone bed, and passes through the dam from the gate house to the downstream toe. Seepage collars were constructed on the pipeline on each side of the core wall. The core wall for the dike is 2 feet thick and 20 feet high. The foundation material for the dike is unknown.
